**TBPOC CONFERENCE CALL
April 22, 2013, 4:00pm – 5:00pm**

RE: Agenda No. - 3a
Program Issues
Item- Status Update on Anchor Rods

Briefing on E2 Anchor Bolts – April 24, 2013

THE SAN FRANCISCO-OAKLAND
BAY BRIDGE
SEISMIC SAFETY PROJECT

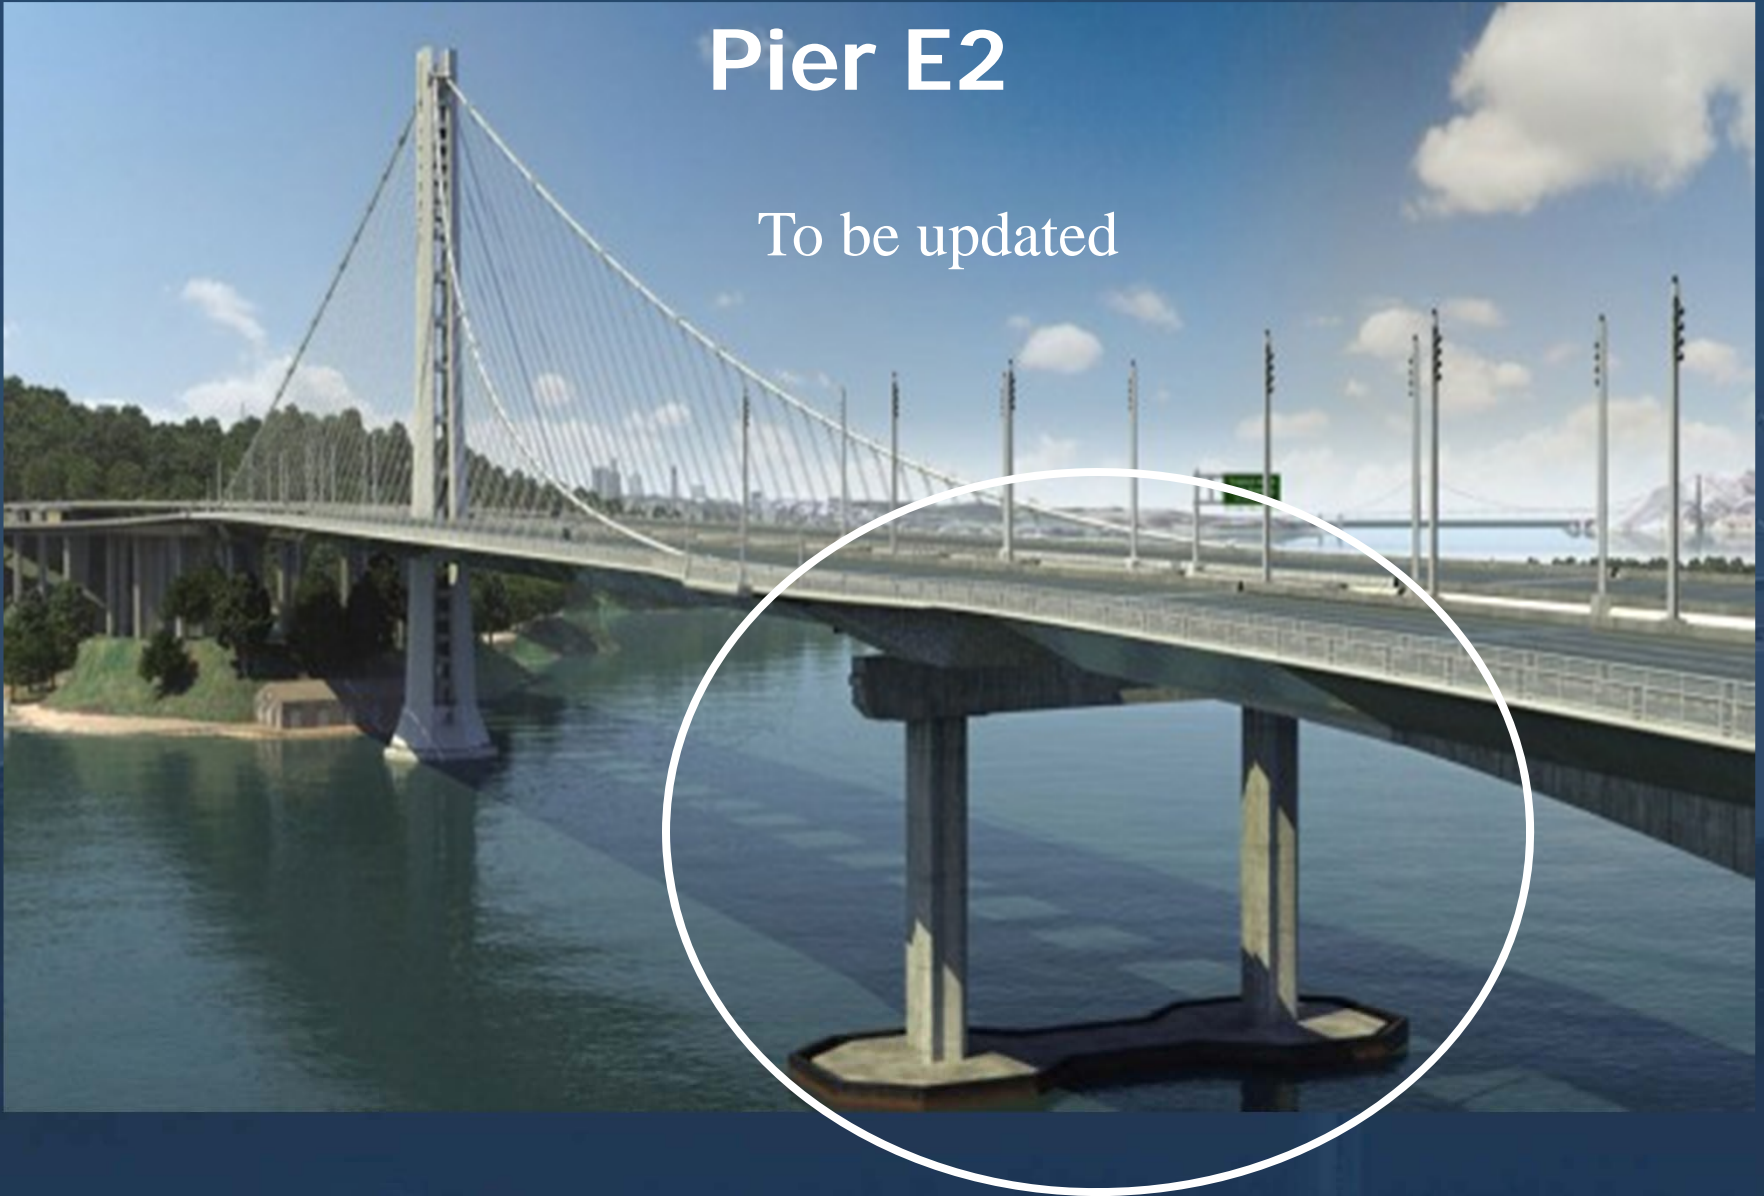
Pier E2

- Bearings and shear keys are secured to E2 by 3 inch diameter anchor bolts, ranging from 9 feet to 24 feet in length.
- 96 Bolts manufactured in 2008 are shown in red.
- 192 Bolts manufactured in 2010 are shown in blue.
